CHANGES IN OXIDATION STATE OF CHROMIUM DURING LDEF EXPOSURE

Johnny L. Golden

Boeing Defense & Space Group

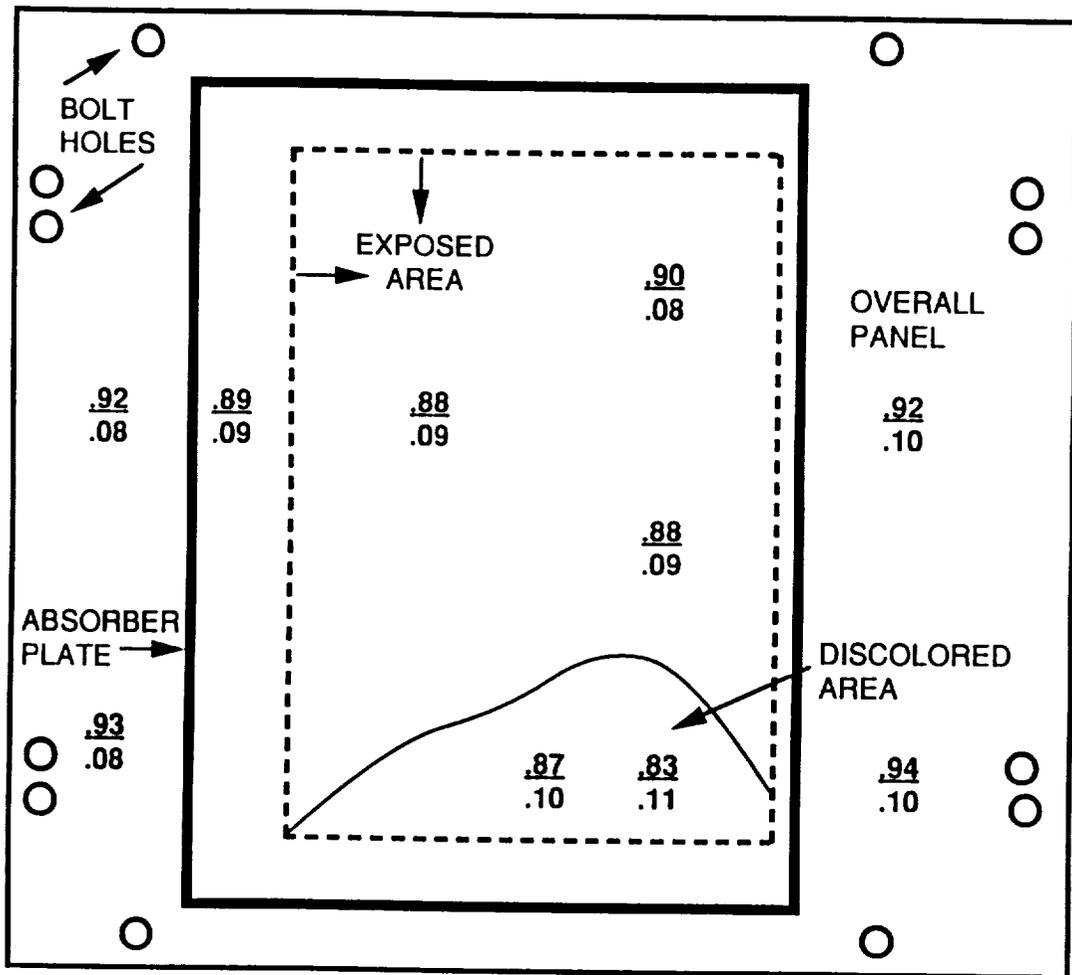
Figure 4.

Optical properties of the black chromium surface were measured and results are shown in figures 3 and 4. Measurements made at unexposed areas of the absorber panel indicate that these areas still meet or exceed the coating specification performance criteria ($\alpha > 0.90$, $\epsilon < 0.10$). Surfaces exposed to atomic oxygen and UV radiation for the full LDEF mission now have a blue tint. The optical properties of the blue area were minimally affected with a slight reduction in absorptance and no change in emittance. However, the surface which was covered with the aluminum flap for an unknown portion of the mission had degraded significantly in absorptance and slightly in emittance, resulting in a tan-color appearance.

Readings are absorptance
emittance

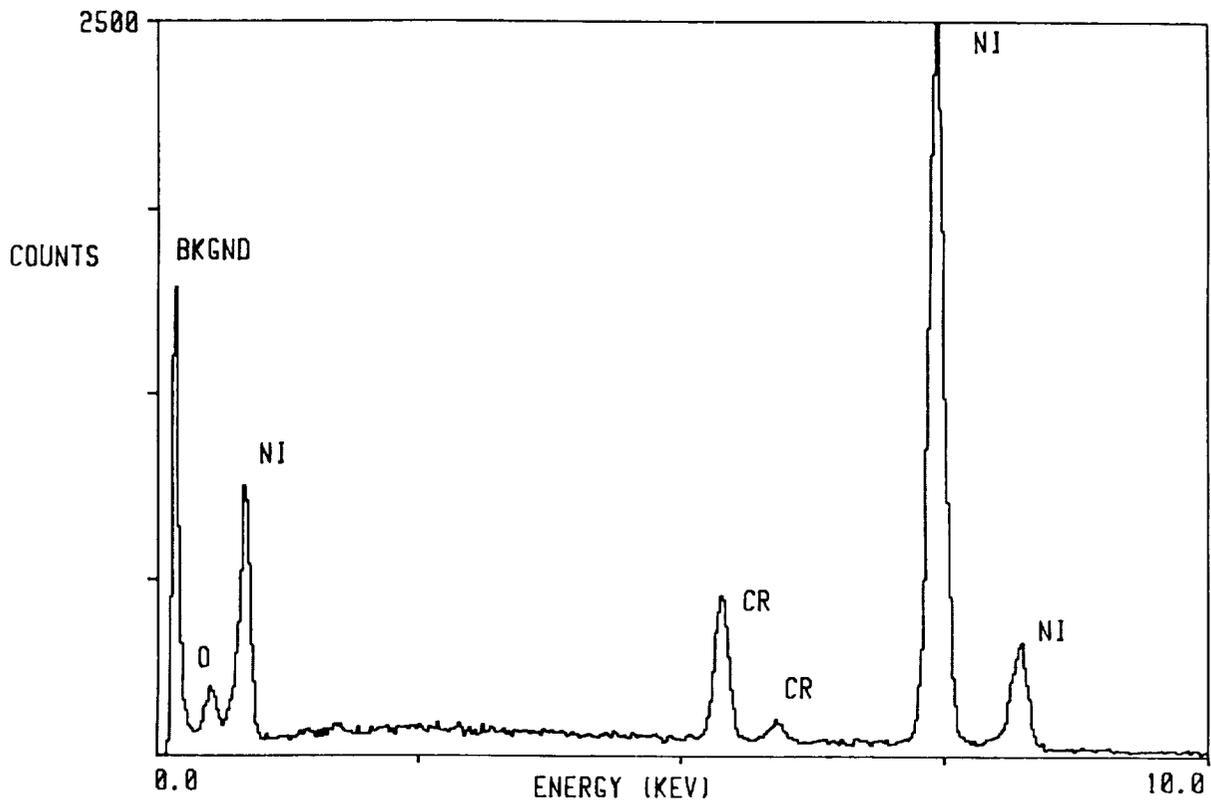
Figure 6. EDX of Discolored Area on Solar Collector Panel.

EDX was performed, an example of which is shown in figure 6. The penetration depth of the EDX analysis permits detection of the nickel underplate through the thin chromium layer. No discernable differences between nominal and discolored areas were detected.

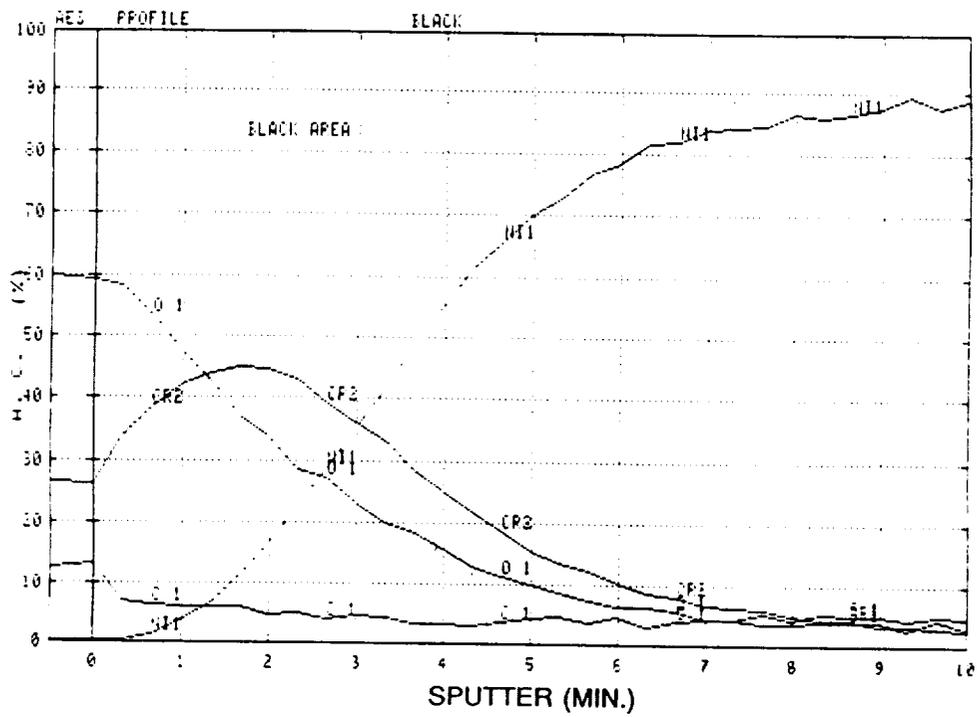
Figure 8. Auger Emission Spectroscopy Profile of Unexposed (Black) Area.

Auger emission spectroscopy profiles were made of the three different areas; these are shown in figures 8, 9, and 10. Differences between the spectra are slight, and the elemental profiles are broad, making interpretation difficult. It appears that the chromium layer has thickened and the oxygen to chromium ratio has increased for the discolored (tan) area, as one compares spectra to those for the blue and then black areas.

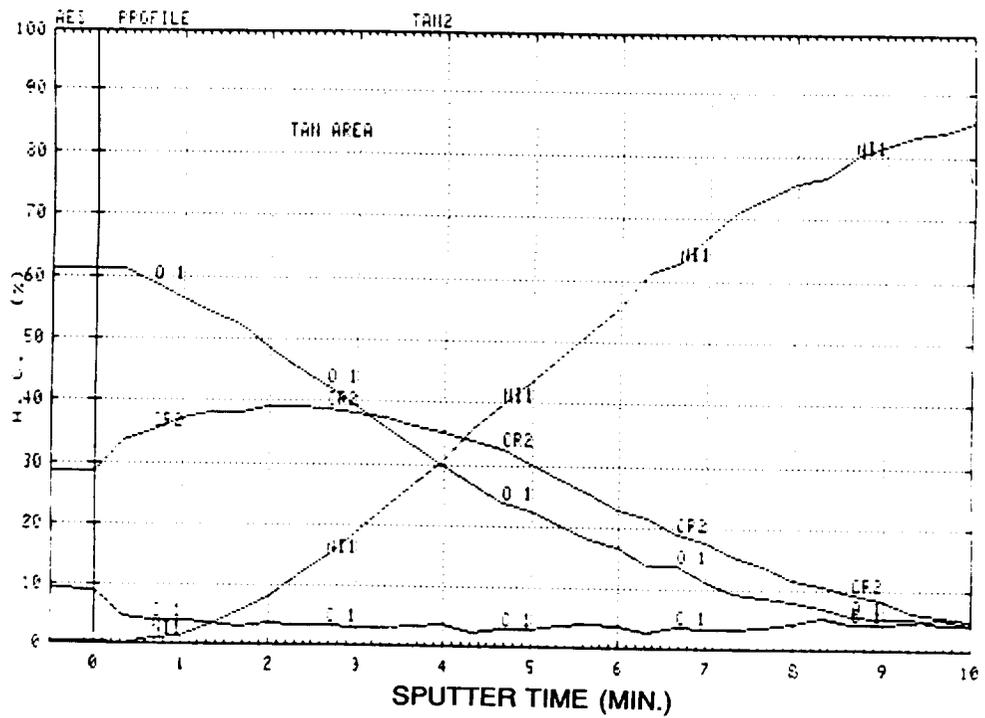
Figure 10. Auger Emission Spectroscopy Profile of Exposed & Discolored (Tan) Area.

These results are not conclusive. But based on the Auger results the following hypothesis is proposed. The discoloration was induced by a thermal effect, caused by the close proximity of the aluminum foil flap to the black chromium coating. The aluminum foil flap, with a low thermal mass and high absorptance to emittance ratio, became very hot, accelerating the atomic oxygen driven oxidation of the chromium. This hypothesis is currently in test using ESCA profiling to determine the chromium oxidation states as a function of depth (fig. 11).
